**State of Louisiana  
Department of Natural Resources  
Coastal Restoration Division**

**2006/2007 Annual Inspection  
Report**

**Bayou Sauvage Refuge Restoration  
Phase I  
(PO-16)**

State Project Number PO-16  
Priority Project List 1

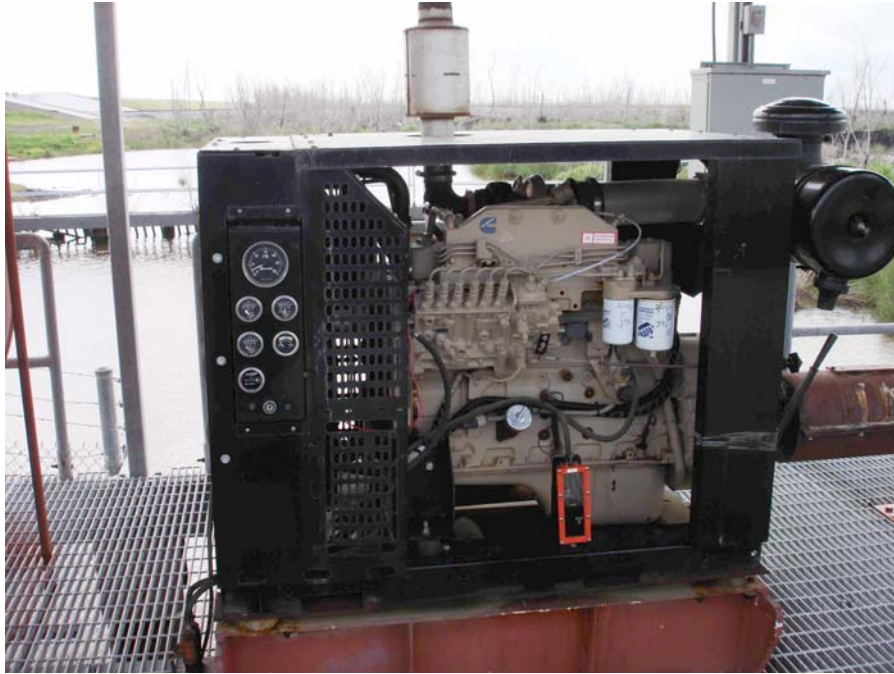
USFWS has replaced the pump and it is fully operational.

**Photo #1 – CTU #5.** New pump engine.

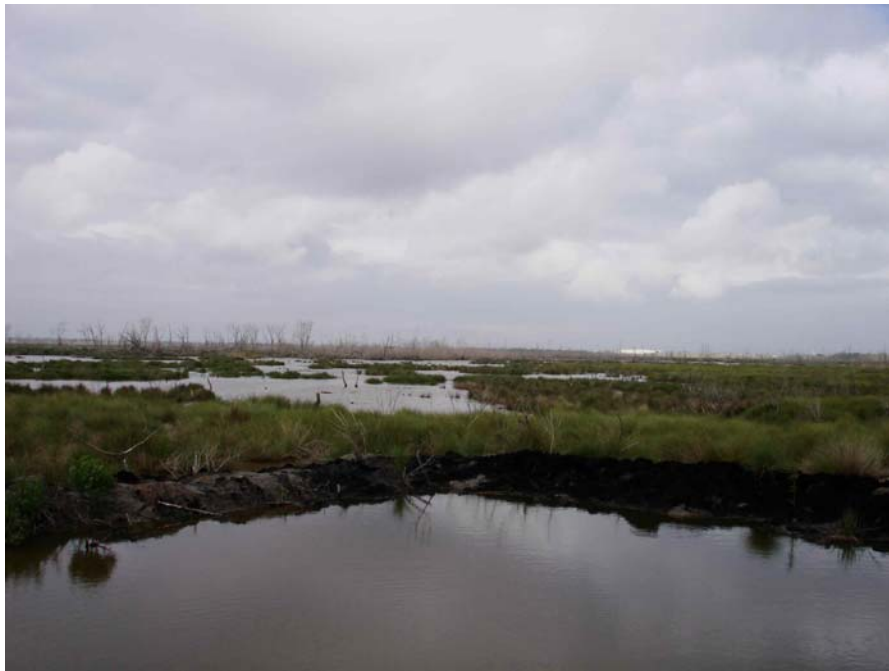
**Photo #2 – CTU #5.** Marsh beyond pump suction basin.

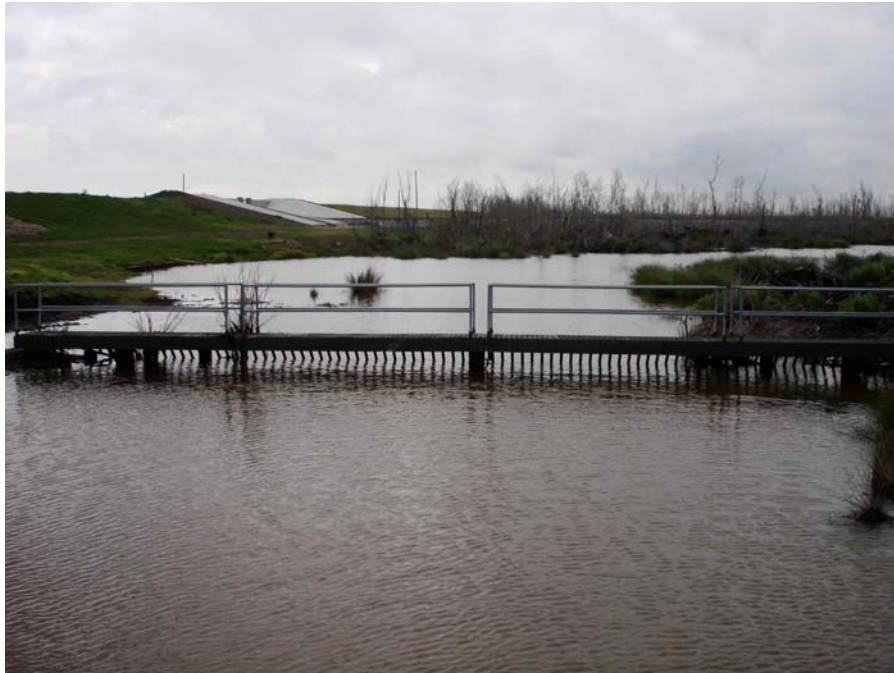
**Photo #3 – CTU #5.** Bar screen with railroad embankment and floodgate in background.

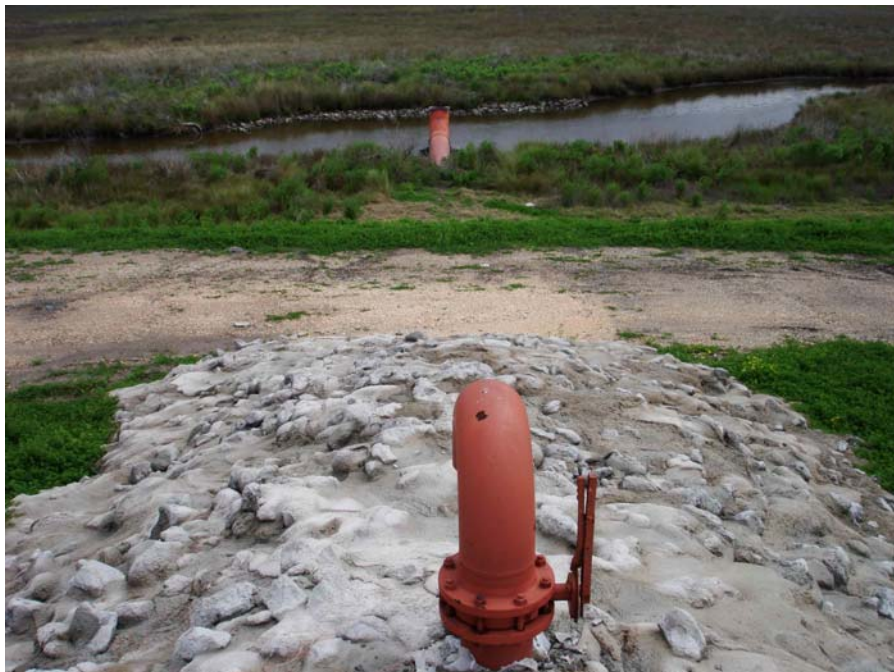
**Photo #4 – CTU #5.** Pump discharge pipe crossing under levee.

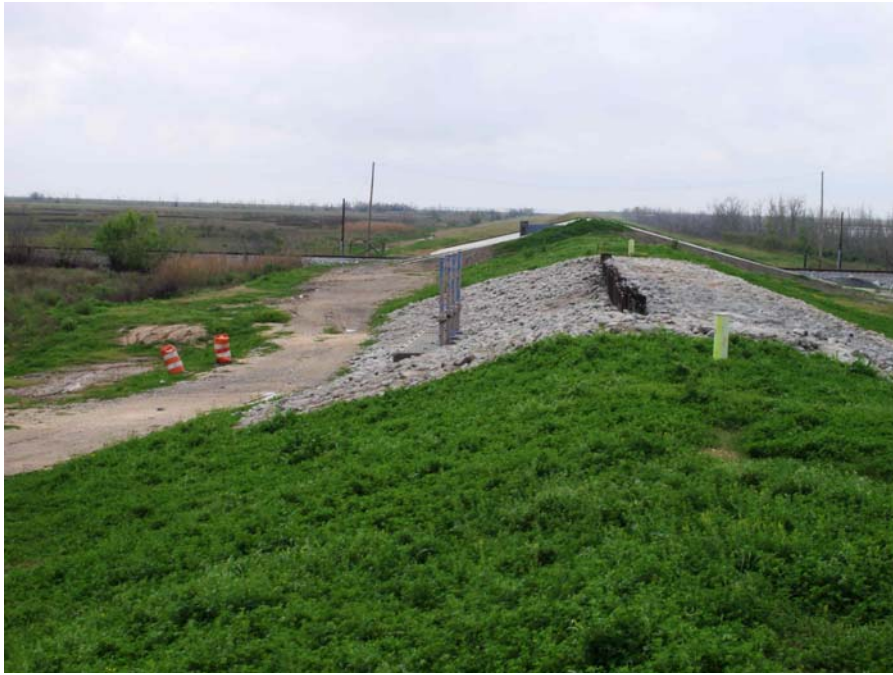
**Photo #5 – Near CTU #5.** Lake Pontchartrain water inlet valves. Not a project feature.

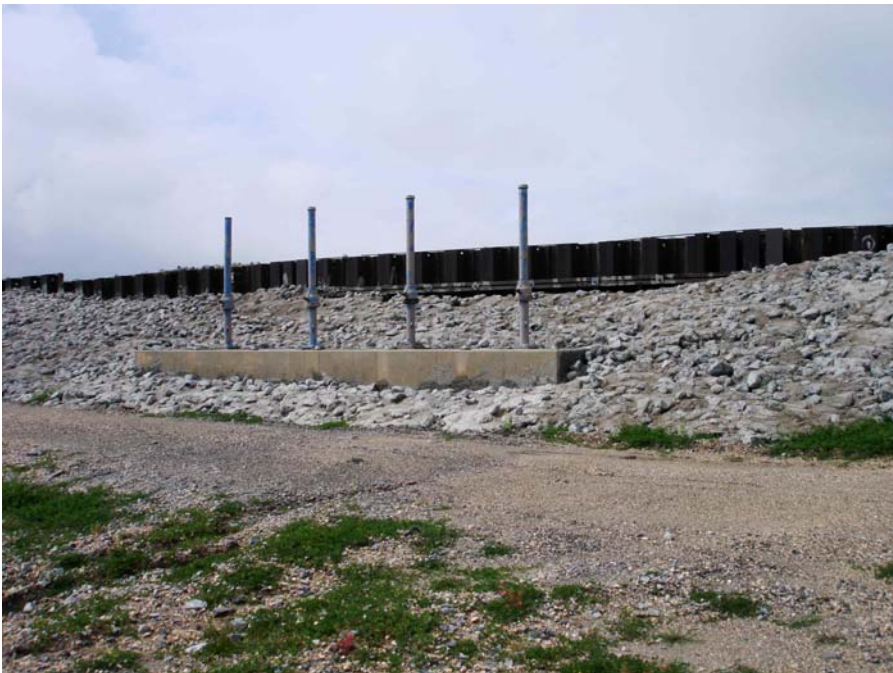
**Photo #6 – Near CTU #5.** Lake Pontchartrain water inlet valves crossing through levee. Not a project feature.
